**NASA TM X-3269**

**ACCELERATED LIFE TEST OF SPUTTERING  
AND ANODE DEPOSIT SPALLING IN  
A SMALL MERCURY ION THRUSTER**

*John L. Power*

*Lewis Research Center*

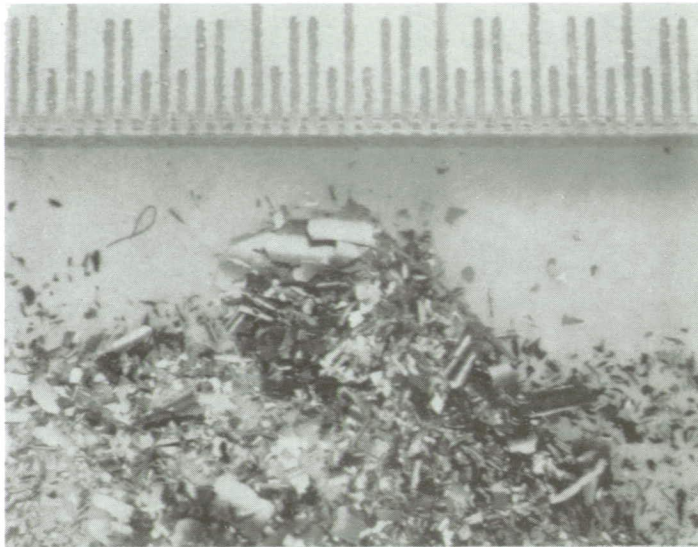
Figure 18. - Portion of loose flakes and material collected from thruster discharge chamber after test. Smallest divisions on ruler, each 0.254 millimeter (0.01 in.).

The curled condition of the flakes retrieved from the discharge chamber following the accelerated life test (fig. 18) suggests that residual forces, present in the coating when the thruster was shut down, were responsible for the spalling of the coating from the smooth anode surfaces and the generation of the observed flakes. Such forces could easily arise from a mismatch in the thermal expansion coefficients of the coating and the substrate, but other driving forces for the spalling from the smooth anode surfaces cannot be ruled out. It is clear, however, from the striking contrast between the coating adhesion to the smooth and the grit-blasted anode surfaces that the roughness of the anode surface has an effect on the coating adhesive forces considerably larger than the magnitude of the spalling forces present, at least for the anode coatings obtained and the thruster conditions prevailing in this work.

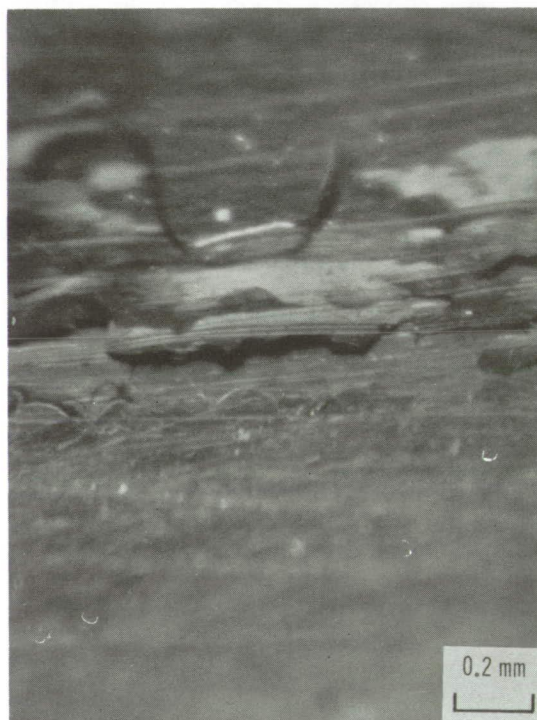
Figure 23. - Photomicrograph of deposits near upstream end of thruster body interior surface after test.

Sputtered material also was visibly deposited on the thruster body interior over all of the unshielded area extending both upstream and downstream from the anode edges. This material did not show much tendency to spall, perhaps because it was unevenly distributed. The thickest deposits, which appeared rather lumpy, were concentrated in a narrow ring located even with the upstream edge of the anode. These deposits may be seen in figure 22. Such deposits also had been observed in the SIT-5 erosion tests (ref. 2). On microscopic examination, the thickest of these deposits did show raised broken edges and the potential for spalling as small flakes (fig. 23).

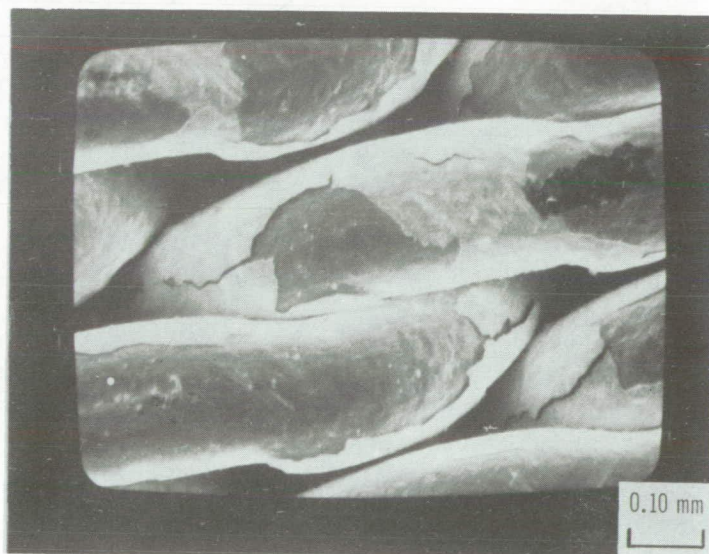
Figure 29. - Electron micrograph of stainless-steel screen anode insert (after test), showing spalled coating areas and cracks.

The coarse screen anode insert showed no macroscopic spalling after the test. Examination of the screen insert with both optical and scanning electron microscopes revealed, however, that in a large number of cases the coating on the exposed screen wires was cracked along the crest of the wires, for a maximum length of one mesh unit. As seen in figure 29, many small flakes of less than one mesh unit length (0.50 mm) spalled or broke off from the edges of these cracks.
